Horn Repair on Lily, my 1971 MGB GT

by Brad Cardwell

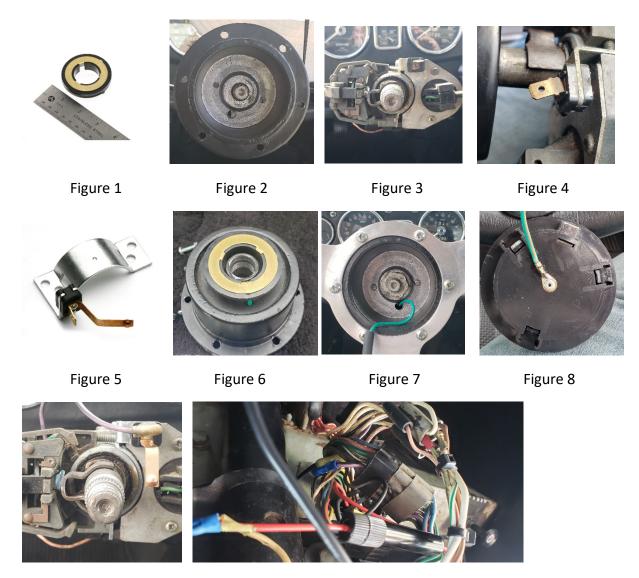
Figure 9 Figure 10

I finally took the time to research and figure out how to make the horn button on the steering wheel center operational. After pulling the steering wheel and looking around as well as studying the wiring diagrams and the Moss catalog I discovered a few things. First there was no slip ring (Moss # 263-755 Fig #1 & 2) on the aftermarket hub, so that went on the Moss to buy list. Second was that the clamp and horn contact (Moss # 141-804 Fig 3, 4 & 5) was broken so that there was no contact with the slip ring, so another item onto the list.

After receiving the parts from Moss, I proceeded to assemble everything. I soldered a wire onto the slip ring and fed it through the hole in the hub (Fig 6 & 7) and then connected it to the horn button (Fig 8). Installed the new clamp and horn contact (Fig 5 & 9) and after installing the steering wheel, I had to find out where they had cut the purple/black wire going to the horn and it was just past the harness connector (Fig 10). After disconnecting that wire from the dash button, I spliced the two purple/black wires together and the button now operates as originally designed.
